THE MEDIEVAL BRIDGE OVER THE RIGNALLA BROOK NEAR FLORENCE: ANALYSIS AND REHABILITATION PROJECT

Stefano Galassi, Michele Paradiso, Giacomo Tempesta, Daniela Zerboni

Department of Architecture – University of Florence (FI) – Italy – e-mail: stefano.galassi@unifi.it

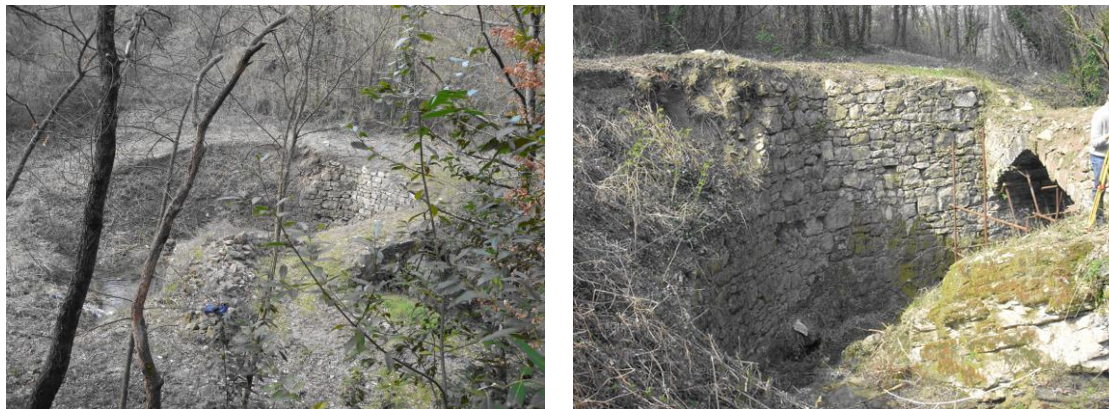
Fig. 1 - Pictures of the bridge and of the retaining wall explaining the reason of the name "Romiolo".

Most probably the round shape of this wall is the reason for the name "Romiolo", that is "ladle", which was given both to the bridge and the brook in the past (fig. 1).

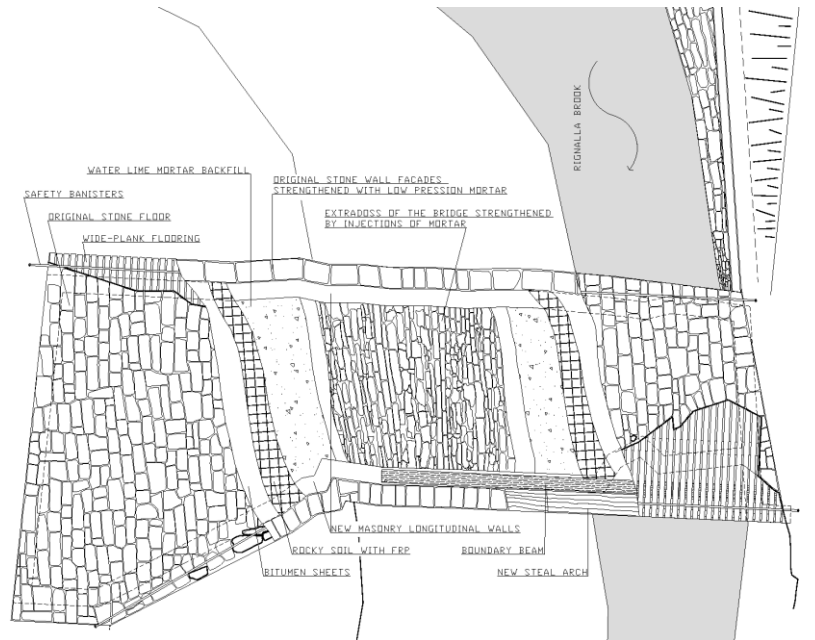
Fig. 8 - The strengthening project (layered representation).

Indeed, to provide a spring surface to the new deck structure downhill, it is necessary to rebuild the part of the retaining wall previously collapsed. To respect the technique and the use of traditional materials, local stones will be employed, but they will be indented from the surface of the existing wall, so as to clearly state the different periods of the buildings (figs. 6,7,8).
