# A comparative study of the lime mortar used for a XIX century masonry bridge located in Cali, Colombia

## Abstract

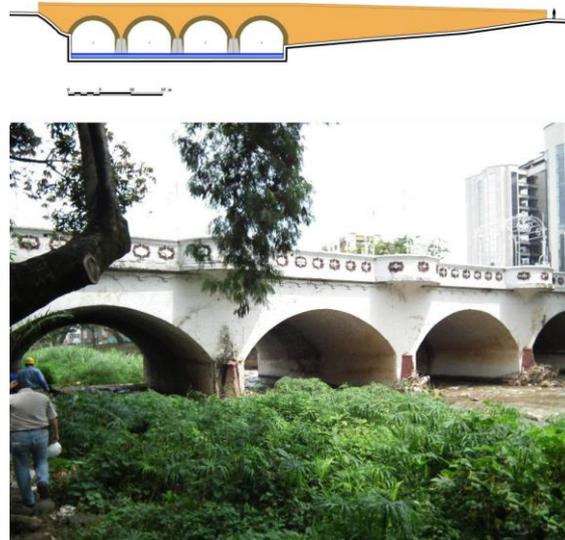
Fig. 1. *Lateral view of a recent picture of Puente Ortiz in the city of Cali (Colombia).*  
[Drawing: E. Sotelo – Photo: J. Galindo]

The Puente de calicanto or Puente Ortiz (Calicanto Bridge or Ortiz Bridge) was built in the city of Cali between 1835 and 1845 across a river with the same name. It was built under the initial direction of a citizen named Jose Montehermoso and later under the supervision of the Franciscan priest, José Ignacio Ortiz. At the time of its commissioning, the structure had five leveling arches and four bow arches over the river that were built entirely from common bricks, which were stuck together with mortar made from a mixture of lime, sand and water (Figure 1). A layer was also prepared from lime mortar and covered the outer walls of the bridge (spandrels) to protect the highly porous bricks from moisture.

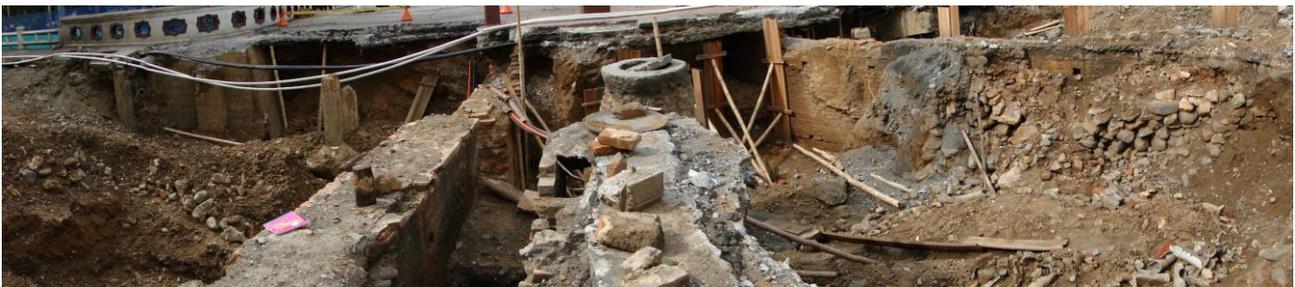
Fig. 2. *Picture of the walls that form the southern end of Puente Ortiz in Cali during the process of archaeological excavation. Left: approach looking "upstream". Right: approach looking "downstream".* [Photo: J. Galindo]

Up until 1918, the structure did not experience any significant changes. Then, an expansion was conducted for the bearing extension board by incorporating concrete crossbeams. In 1945, two separate bridges were attached with concrete on each side of the original bridge and were buried under the ground to the extreme north and south of the nineteenth century original construction. In 2011, an urban archaeological excavation managed to unearth the walls of the southern end (approaches), which were in good condition, allowing them to obtain samples of the types of lime mortar used in both the bricks and the paste in the plaster of their spandrels (Figure 2).

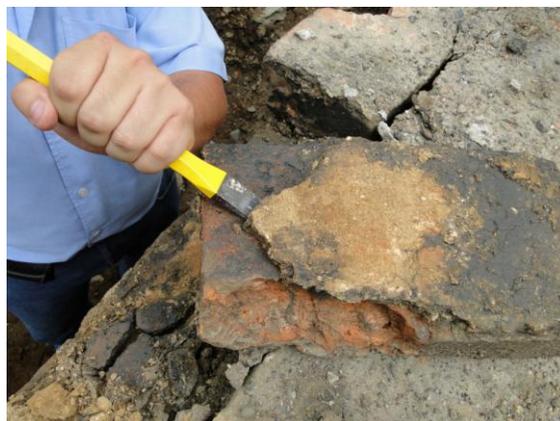
Fig. 3. *Sample extraction of the mortar paste at Puente Ortiz.*

To perform a differential analysis between the mortar paste of the bricks and the mortar of the plaster, samples were collected from each source via a manual procedure in which a flat chisel tip was used (Figure 3).

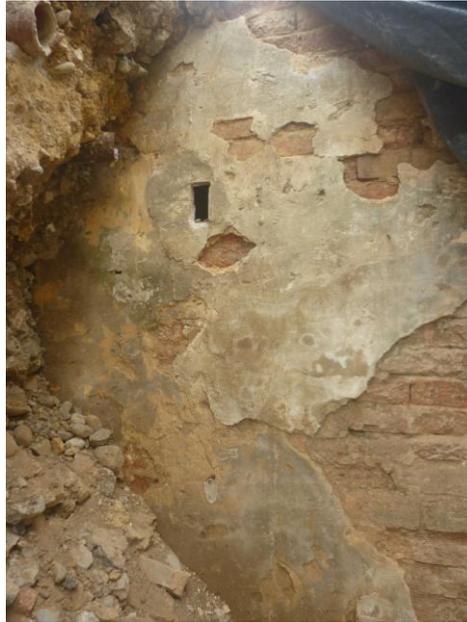
Fig. 4. A sample extraction site of plaster mortar at Puente Ortiz  
[Photo: J. Galindo]

Three (3) mortar paste specimens were obtained from the approach that looks towards the east, and two (2) specimens were obtained from the approach that looks towards the west. The plastering mortar samples were obtained entirely from the approach that looks towards the west, in which a surface cloth of 4.00 m<sup>2</sup> was maintained in a good condition, with traces of the original yellow pigment (Figure 4).

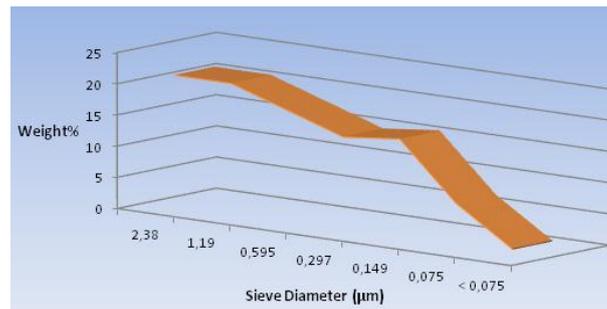
Sieve	Opening (µm)	% Kept
No. 8	2380	21
No. 16	1190	21
No. 30	595	18
No. 50	297	15
No. 100	149	16
No. 200	75	7
Depth	<75	1

Fig. 5. The grain size distribution for the samples of mortar paste at Puente Ortiz (POMP-03)

Figure 5 shows the grain size distribution for the mortar paste aggregate samples at Puente Ortiz in the city of Cali. A trend was observed in the granulometric analysis of sample POMP-03, corresponding to a bimodal distribution (approximately 1190 microns and 297 microns), with the descent trend starting with the grain size of 1190 microns. In the sample, the size of the finer particles (<75 microns) is less than 6% of the sample. Fifty percent of the grains fall within a high range between 1190 microns and 595 microns.

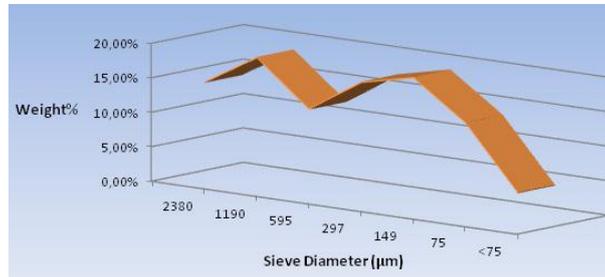
Sieve	Opening (µm)	% Kept
No. 8	2380	14
No. 16	1190	19
No. 30	595	12
No. 50	297	17
No. 100	149	19
No. 200	75	14
Depth	<75	5

Fig. 6. The grain size distribution for the samples of mortar plaster at Puente Ortiz (POMR-02)

Figure 6 shows the grain size distribution of the sample plaster mortar at Puente Ortiz. The grain size distribution of the sand mortar sample POMR-02 shows a bimodal distribution (approximately 1190 microns and 149 microns) that is relatively homogeneous, where the size of the finer particles (<75 microns) is less than 6% of the sample. Approximately 50.12% of the grains fall within a low range between 595 microns and 75 microns. It is concluded that fine sand was used for the preparation of the mortar plastering and not for the mortar paste.

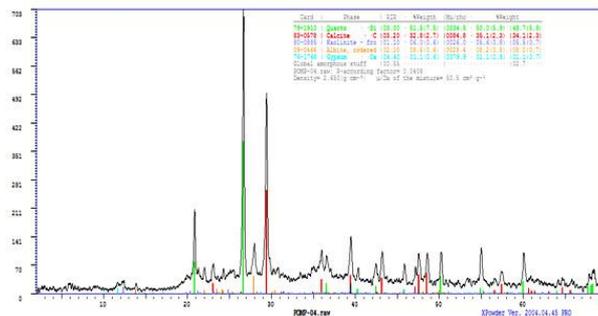
Fig. 7. X-ray diffraction for the mortar paste samples at Puente Ortiz in Cali (POMP-02).

Figure 7 shows the X-ray diffraction pattern for mortar paste sample POMP-02. The presence of quartz [SiO<sub>2</sub>] evidences the use of a quartzitic sand mortar in the original formulation (Table 3). Calcite [CaCO<sub>3</sub>] is indicative of the use of lime. By comparing the intensities, it can be established that the sample is rich in sand in relation to the content of calcite.

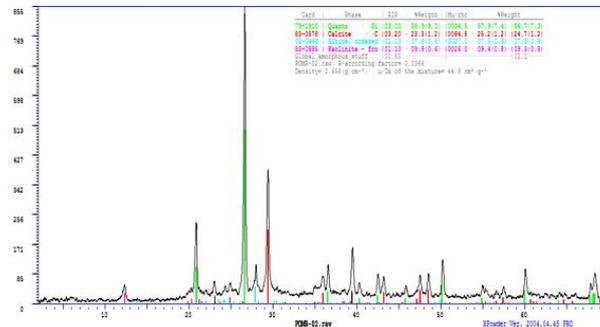
Fig. 8. X-ray diffraction for the mortar plaster samples at Puente Ortiz in Cali (POMR-01).

Figure 8 shows the X-ray diffraction pattern for plastering mortar sample POMR-01. The presence of quartz [SiO<sub>2</sub>] evidences the use of quartzitic sand in the formulation of the original mortar (Table 3). Calcite [CaCO<sub>3</sub>] is indicative of the use of lime and its chemical transformation into calcium carbonate.

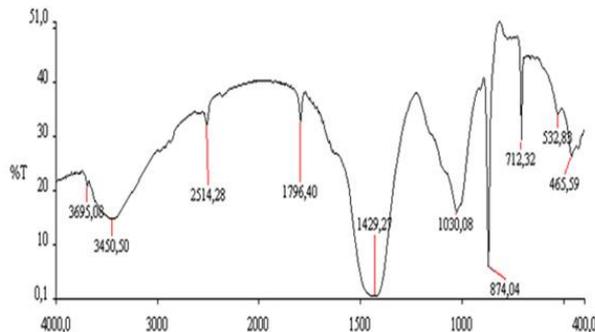
Fig. 9. Spectroscopy of the mortar paste samples at Puente Ortiz in Cali (POMP-03).

Figure 9 shows the FT-IR spectrum of mortar paste sample POMP-03. The bands at 2514 cm<sup>-1</sup>, 1429 cm<sup>-1</sup>, 874 cm<sup>-1</sup> and 712 cm<sup>-1</sup> correspond to the three different modes of elongation of the C-O bonds. The thin band at 1796 cm<sup>-1</sup> is associated with the carbonate C-O bond. All of these bands allow for the identification of calcium carbonate (CaCO<sub>3</sub>).

The bands at 3450 cm<sup>-1</sup> and 1628 cm<sup>-1</sup> can be explained by the presence of the hydroxide ions in water (Genestar, Pons & More, 2006). The water could have been subject to hydraulic compounds, such as silicate and aluminate hydrates (Silva & Wenk Monteiro, 2005). The band at 532 cm<sup>-1</sup> may indicate the presence of oxides. The bands at 1030 cm<sup>-1</sup> and 465 cm<sup>-1</sup> indicate the presence of quartz (Maravelaki et al., 2005).

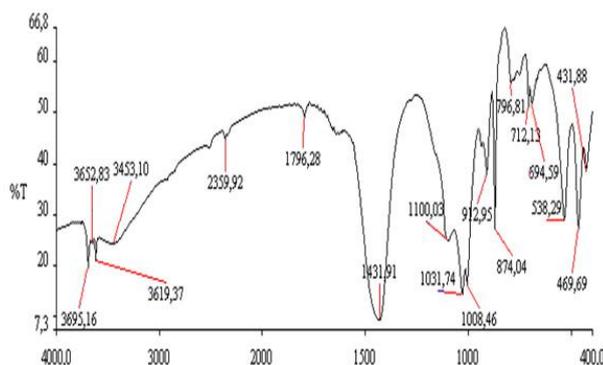
Fig. 10. Plaster mortar sample (POMR-02) spectroscopy at Puente Ortiz in Cali

Figure 10 shows the FTIR spectra for plastering mortar sample POMR-02. The bands at 1431 cm<sup>-1</sup>, 874 cm<sup>-1</sup> and 712 cm<sup>-1</sup> correspond to the three different stretching modes of the CO bonds. The narrow and intense band at 1796 cm<sup>-1</sup> is associated with a carbonate CO bond. The bands at 3453 cm<sup>-1</sup> and 1622 cm<sup>-1</sup> can be explained by the presence of the hydroxide ions in water (Genestar, Pons & More, 2006). The water could have been subject to hydraulic compounds, such as silicate and aluminate hydrates (Silva & Wenk Monteiro, 2005).

The band at 538 cm<sup>-1</sup> may indicate the presence of an oxide (Genestar, Pons & More, 2006). The bands at 1100 cm<sup>-1</sup>, 1031 cm<sup>-1</sup>, 796 cm<sup>-1</sup> and 469 cm<sup>-1</sup> indicate the presence of quartz (Maravelaki et al., 2005). The vibrations at 1008 cm<sup>-1</sup> could indicate the presence of silicoaluminate hydrates.

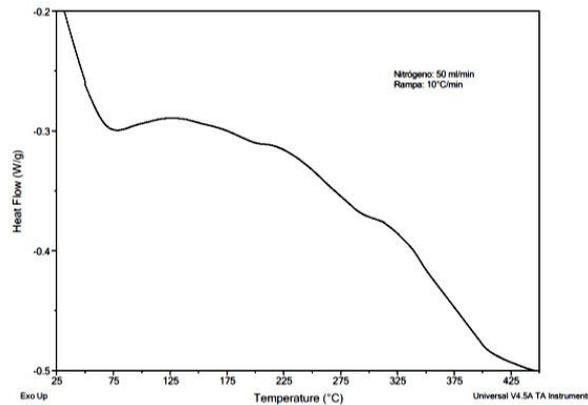
Fig. 11. *Differential scanning calorimetry of the mortar paste sample at Puente Ortiz (POMP-03).*

The DSC curve of mortar paste sample POMP-03 is shown in Figure 11. The analysis indicates a pure lime mortar. Typically, most of the plaster consists of calcite [CaCO<sub>3</sub>] without the presence of

hydraulic components because they are hygroscopic and because no significant endothermic peak in the range of 100-450 °C was observed. This analysis allows for the differentiation of the hydraulic mortars from the lime mortars in which the latter contains smaller amounts of absorbed water (Bakolas et al., 1998).

The thermal analysis indicates the presence of a limited amount of clay minerals. The insignificant endothermic effects at 200 °C, 292 °C and 408 °C can be attributed to small amounts of silicate and aluminate in the sample. The thermal transition at 78 °C indicates the presence of hygroscopic water. The endothermic peak at 408 °C indicates the dehydration of kaolinite.

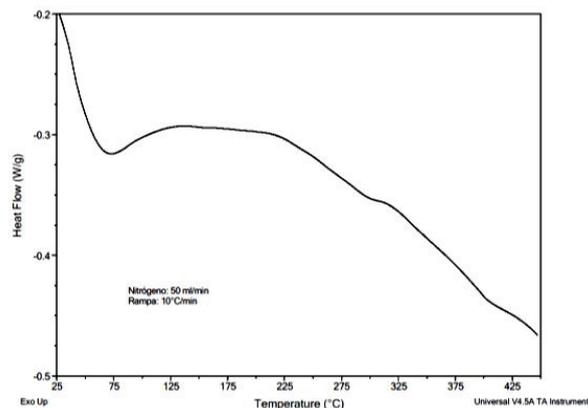
Fig. 12. *Differential scanning calorimetry of the plaster mortar samples at Puente Ortiz in Cali (POMR-02).*

The DSC curve of mortar plaster sample POMR-02 is shown in Figure 12. The spectrum shows a lime mortar, which typically has a very small number of hydraulic components. Three significant endothermic reactions are also observed at 202 °C, 302 °C and 405 °C, which may indicate the dehydration of a compound containing aluminum hydraulic and/or silicon. The endothermic peak at 77 °C indicates the presence of hygroscopic water. A weak endothermic reaction in the curve indicates the reorganization of the octahedral sheets of kaolinite at 302 °C, as demonstrated by Kakali et al. (2001).

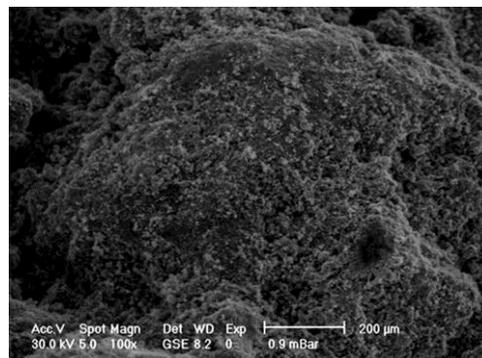
Fig. 13. *Scanning electron microscopy of the mortar paste samples at Puente Ortiz in Cali (POMP-03).*

An image obtained using scanning electron microscopy for mortar paste sample POMP-03 is shown in Figure 13. The observations made by SEM show grains of sand with approximately 1 mm diameters, the surface layers of which are covered with fine powders, particularly CaCO<sub>3</sub>. Below these fine powders is a high concentration of solid grains with low porosity, which do not show cracks or fractures. The limits observed between the larger particles appear to have a good grip.

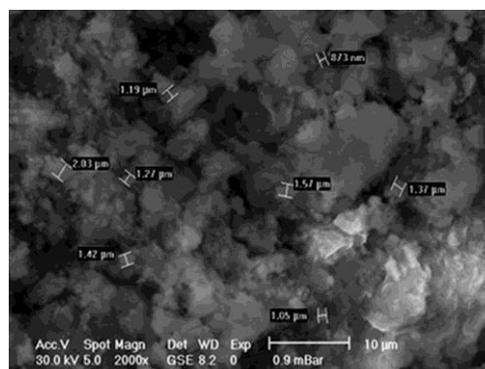
Fig. 14. *Scanning electron microscopy of the sample of mortar paste at Puente Ortiz in Cali (POMP-03).*

The chemical composition of the large particles showed a higher content of silicon and aluminum in accordance with the energy dispersive spectrometry (Figure 14) analysis. The XRD analysis indicates that the main component of the large particles is quartz (SiO<sub>2</sub>), and a major component of fine particles is calcite. Larger solid particles indicate that the material is mechanically strong. The larger particles appear to be connected through the fine powders.

Amplification of the fine powders allows us to observe the irregular morphology of the CaCO<sub>3</sub> crystals derived from the carbonation of the lime, which show an inhomogeneous grain size distribution ranging from 870 nm to approximately 5 microns. The size and texture of the calcite grains are formed according to the environmental conditions of carbonation. The material obtained from the pozzolanic reaction by-products is not readily identifiable (Elsen, 2006). No fibers, which would improve the mechanical behavior of the material, are observed.

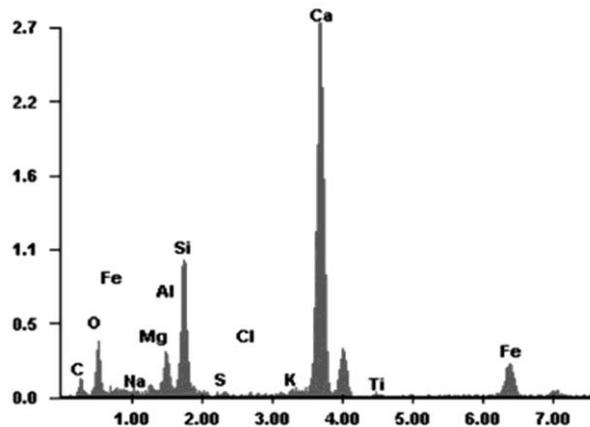
Fig. 15. The EDS analysis of the mortar paste samples at Puente Ortiz (POMP-03).

The SEM-EDS microanalysis (Figure 15) mainly identifies the elements of Ca, Si and Al, thus confirming the presence of the relevant compounds of the mortar, such as calcite, quartz and Al, indicating the presence of clay compounds. In addition, other elements are identified indicating the presence of impurities, such as Fe.

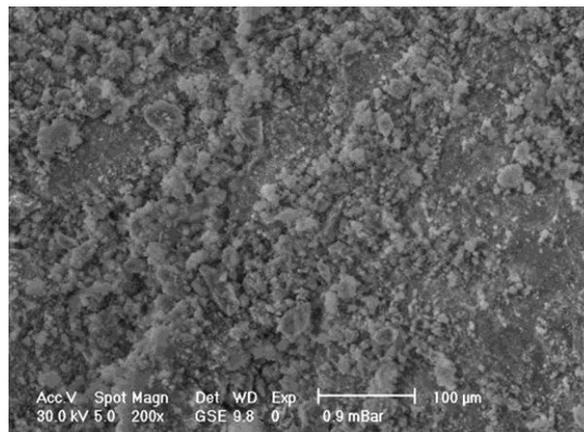
Fig. 16. Scanning electron microscopy of the plaster mortar samples at Puente Ortiz in Cali (POMR-02).

The scanning electron microscopy of plastering mortar samples POMR-02 is shown in Figure 16. The figure shows a surface layer of powders of calcite coated with quartz grains that provide a connection between them. These powders almost completely fill the spaces between the sand particles, which is a feature that determines the low permeability to the masonry interior, thus preserving harmful agents such as atmospheric CO<sub>2</sub> and H<sub>2</sub>O.

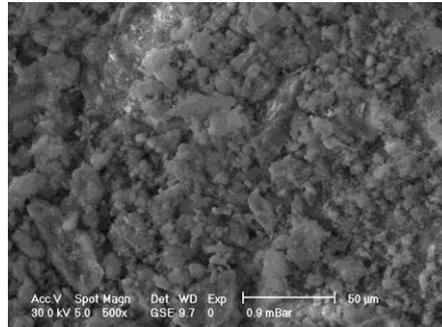
Fig. 17. Scanning electron microscopy of the plaster mortar samples at Puente Ortiz in Cali (POMR-02).

Few pores are observed (Figure 17), which were possibly formed during curing and carbonation. Good compaction of the powders is also observed. No fibers or gels are observed, indicating a calcium silicate hydrate phase (CSH), which usually crystallizes on the surface. This finding confirms that the clay material failed to be activated.

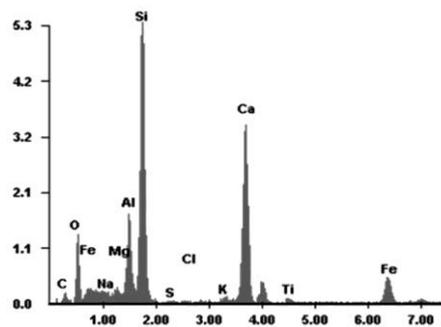
Fig. 18. The EDS analysis for mortar plaster samples at Puente Ortiz in Cali (POMR-02).

A chemical mapping (Table 4) of the surface primarily identifies elements Si, Ca and Al (Figure 18). The chemical composition of the large particles showed higher contents of Si and Al in accordance with the energy dispersive spectrometry (EDS) analysis. The main element of the fine particles is Ca.
